# TRAFFIC COMMISSION REPORT

#### **SAFETY OF COUNTDOWN PEDESTRIAN SIGNAL INDICATIONS**

# **The Effects of Pedestrian Countdown Signals in Lake Buena Vista**

# **Pedestrian Countdown Signals: An Experimental Evaluation**

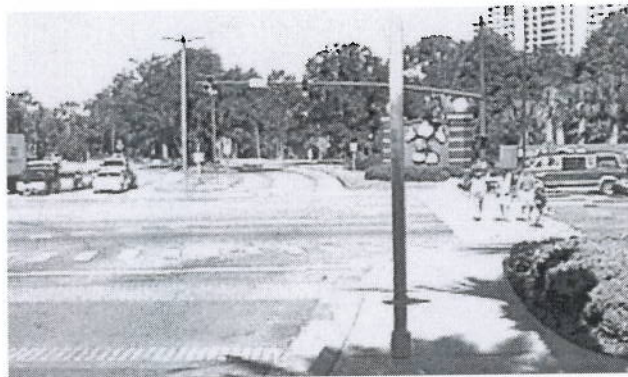
**Figure 3.** State Route 535 at Hotel Plaza Boulevard (countdown signal site).

**Figure 4.** SR 535 at Hotel Plaza Boulevard.

The northside crosswalk is equipped with a countdown signal. It starts at 37 seconds, when the Walk first appears. At 25 seconds, the flashing Don't Walk appears. At 0 seconds, the steady Don't Walk appears and the timer display disappears.

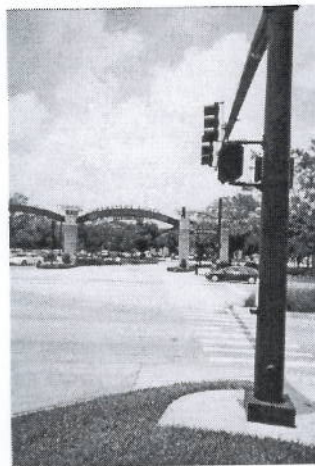
This location is one traffic light (about 1/4 mile) east of its corresponding treatment site (Buena Vista Drive at entrance to Team Disney). Buena Vista Drive is an east-west roadway with a raised grass median (Figure 9). There are three through lanes and a left-turn lane in each direction. The ADT is 30,500 vehicles per day and the speed limit is 56 km / h (35 mi / h). Downtown Disney is on the north side of Buena Vista Drive. The Disney Casting Center serves as the Walt Disney World™ employment office, and is on the south side.

**Figure 9.** Buena Vista Drive at Disney Casting Center (control site).

Buena Vista Drive at entrance to Disney Casting Center, east leg (control site for Buena Vista Drive / Team Disney)

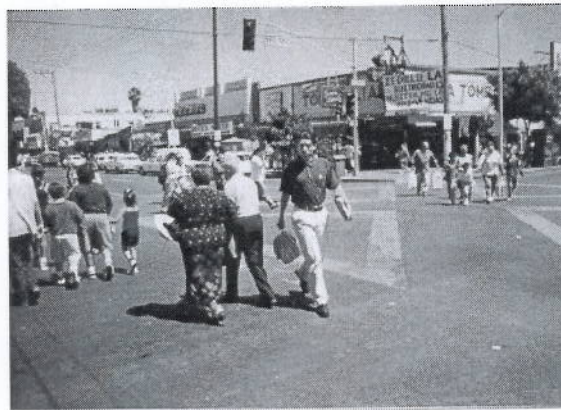
**Figure 13.** With scramble timing, pedestrians are allowed to cross in any direction, including diagonally.

Two alternatives are exclusive timing and scramble (or Barnes dance) timing. With exclusive timing, all vehicular traffic is stopped and pedestrians are allowed to cross in any crosswalk: the Walk interval is displayed for all crosswalks at the same time, while all motorists have a red traffic signal. Exclusive timing has been associated with approximately a fifty percent reduction in motor vehicle - pedestrian crashes as compared to standard timing (Zegeer *et al.*, 1985). With scramble timing, all vehicular traffic is stopped and pedestrians are allowed to cross in any crosswalk or diagonally across the intersection (Figure 13). These exclusive timing schemes are most appropriate in downtown signalized intersections with high pedestrian volumes (1,200 or more per day), and relatively low vehicle speeds and volumes. Such timing schemes will typically increase vehicle and pedestrian delay, since longer signal cycles are required, and it may
